Comparison of 2021 IECC Residential Cost Effectiveness Analyses

This document is intended to provide a comparison of two reports the *2021 IECC Residential Cost Effectiveness Analysis* published for the National Association of Homebuilders (NAHB) by Home Innovation Research Labs (HIRL) in June 2021, hereafter referred to as the HIRL report¹; and the report of the same name published by ICF in January 2022, hereafter referred to as the ICF report. The purpose of this document is to identify concerns and issues in the HIRL report, which were addressed in the ICF report.

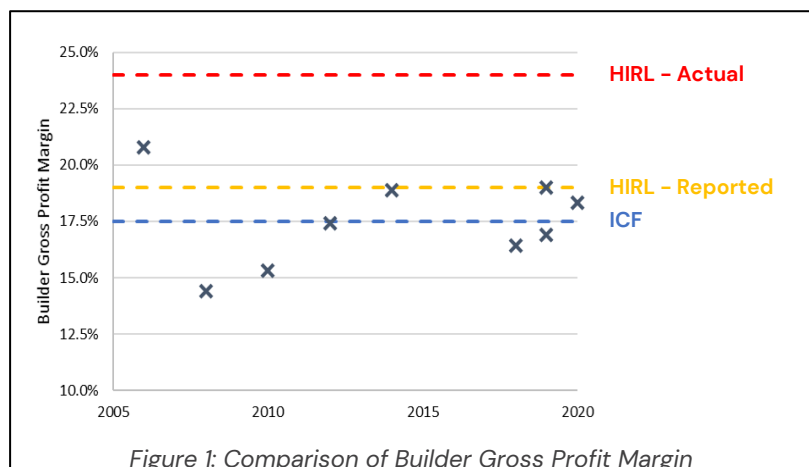
Figure 1: Comparison of Builder Gross Profit Margin

available for builder gross profit margin is shown by black X's, with their average – the value used in the ICF report – shown by the blue line. The profit margin used in the ICF report is a more representative value, as the value reported to have been used in the HIRL report is the highest profit margin seen since 2006, and the value that was actually used is higher than any reported historical profit margin.

Additionally, the ICF report considered changes in builder profit margins over time and used an average value representing all data that was available. In figure 1, the data

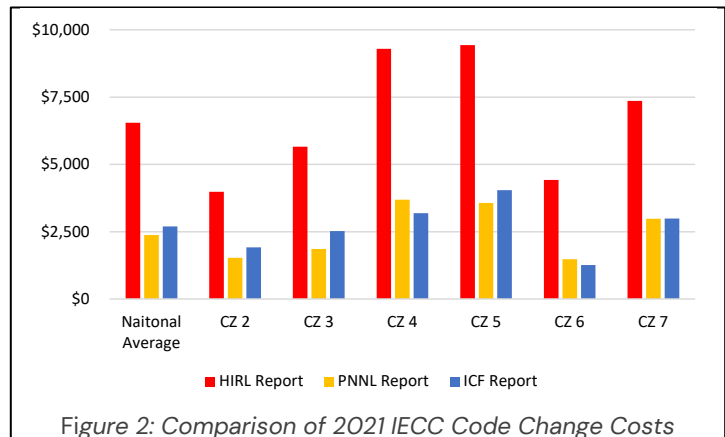
Figure 2: Comparison of 2021 IECC Code Change Costs

When reviewing the HIRL report, the high estimated incremental cost of code changes conflicted with other data sources, specifically Northwest national Laboratory’s (PNNL’s) *National Cost Effectiveness of the Residential Provisions of the 2021 IECC*, as shown in Figure 2.⁴ After reviewing and updating cost data, the ICF report concluded costs were generally in line with the PNNL report, instead of 2 to 3 times higher as shown in the HIRL report.

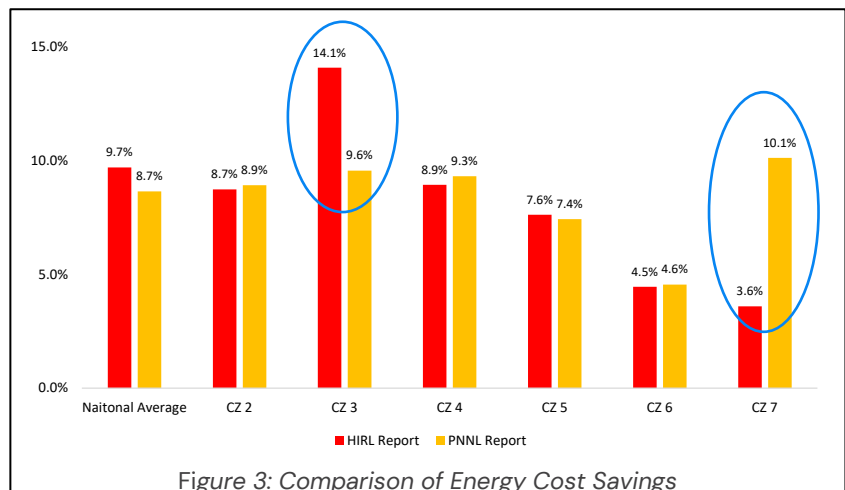
Figure 3: Comparison of Energy Cost Savings

Savings from the HIRL report and PNNL’s savings estimates (*Energy Savings Analysis: 2021 IECC for Residential Buildings*⁵), were compared and national average savings were comparable (9.7% for HIRL and 8.7% for PNNL). However, some results in specific climate zones showed significant differences as shown in Figure 3 (i.e., climate zones 3 and 7). Due to the robustness of the methodology that PNNL’s savings estimates used, it is likely that there is an issue with the modeled energy use in the HIRL report. However, this cannot be confirmed, nor could the potential impact on the cost-effectiveness be determined.
